Fire resistance test report

Test standard: [Sections 2 and 10 of AS 1530.4:2014](#)

Test sponsor: [Trafalgar Group](#)

Job number: [FRT200257](#)

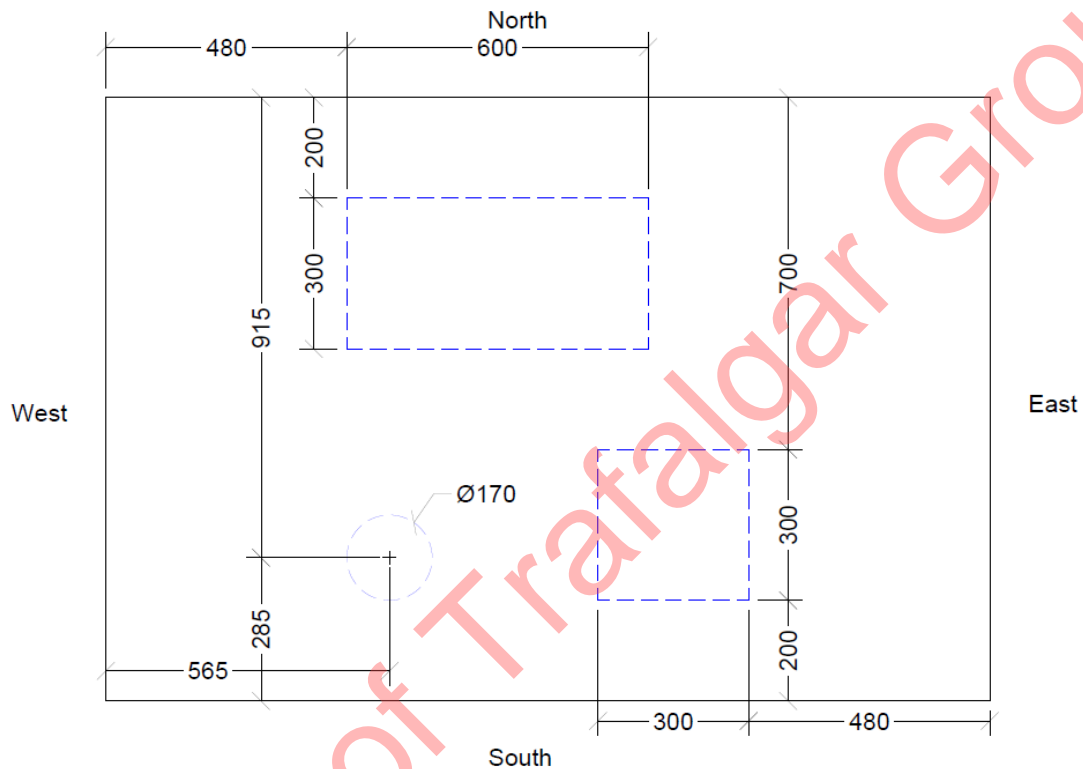
Figure 1 Plan view of aperture location (unexposed side)

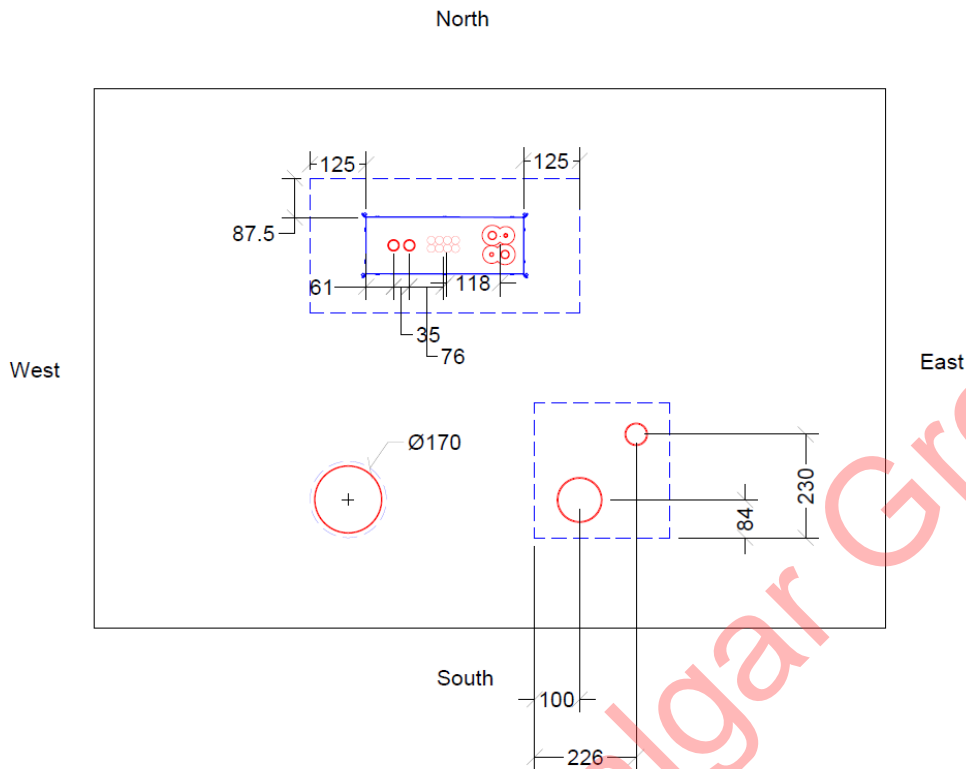
Figure 2 Plan view of service location (unexposed side)

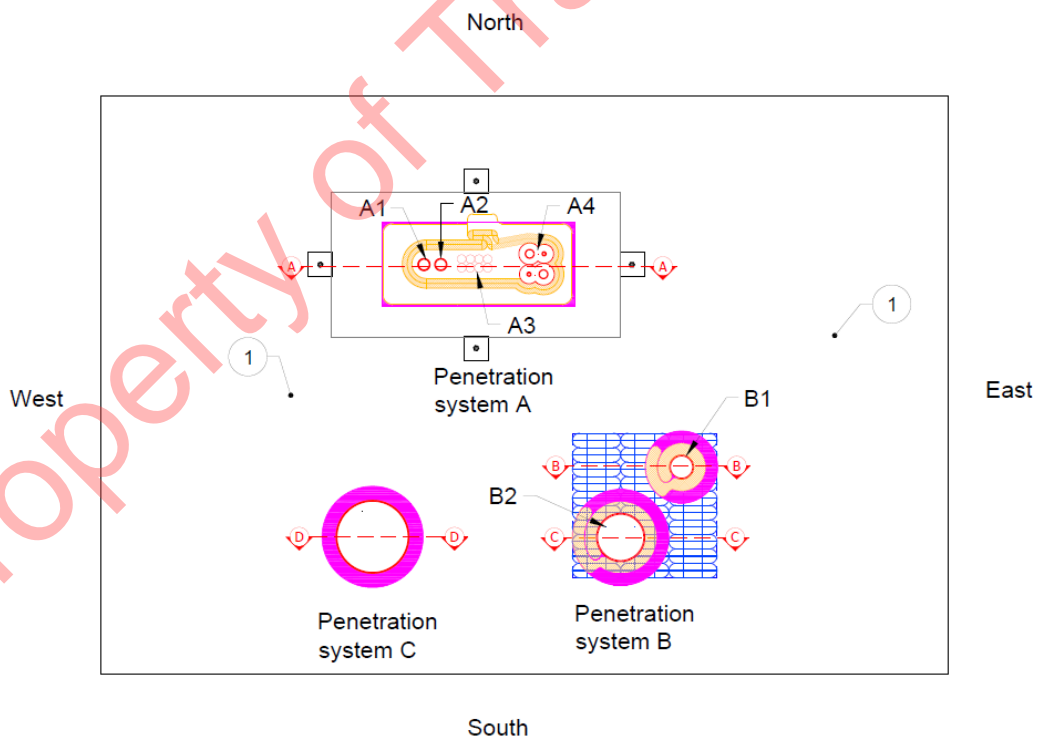
Figure 3 Plan view of test specimen (unexposed side)

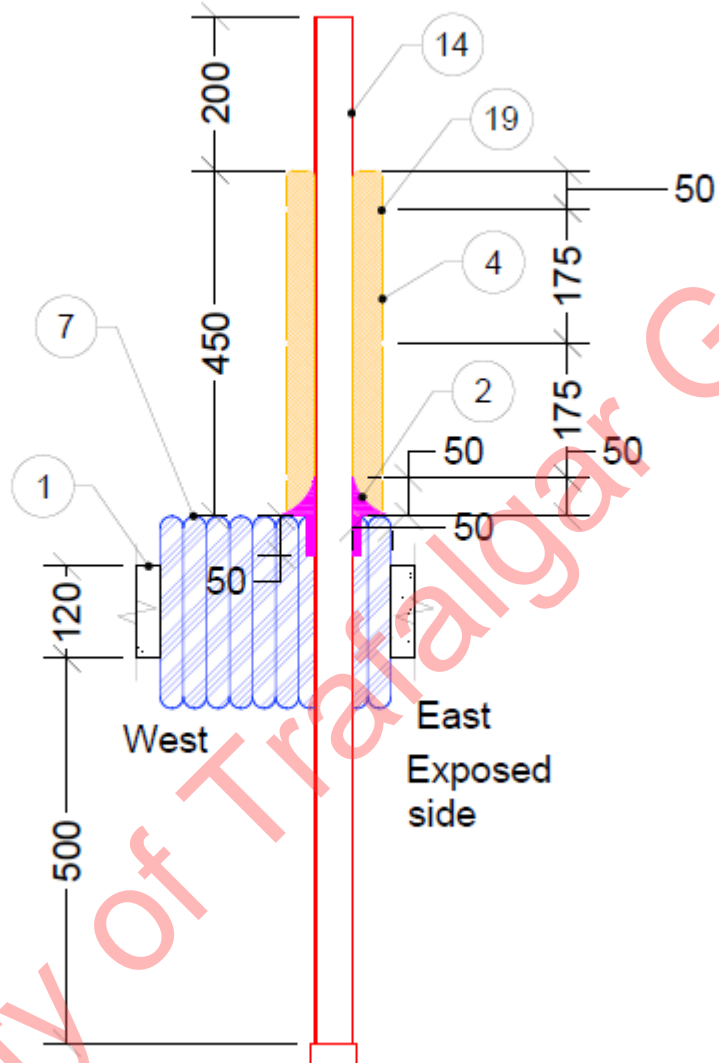
Figure 5 Cross-section B-B

Penetration
system B2

B2	The service was supported at 730 mm above the separating element with pipe clamps onto channels.
	Main aperture size	300 mm wide x 300 mm long	
	Main fire-stopping protection

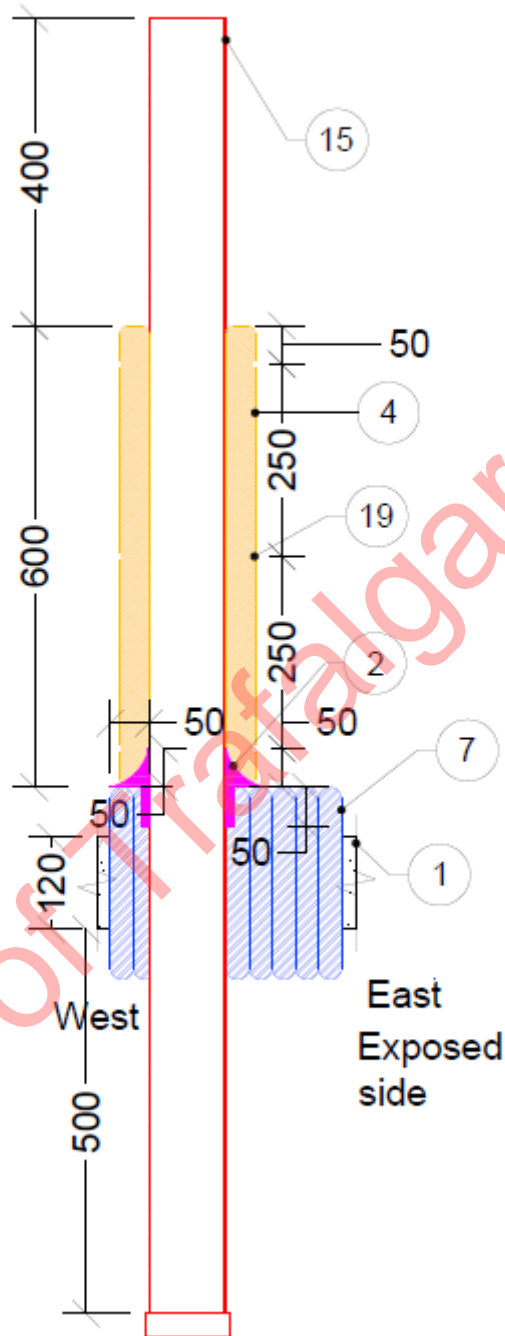
Figure 6 Cross-section C-C

Penetration system C

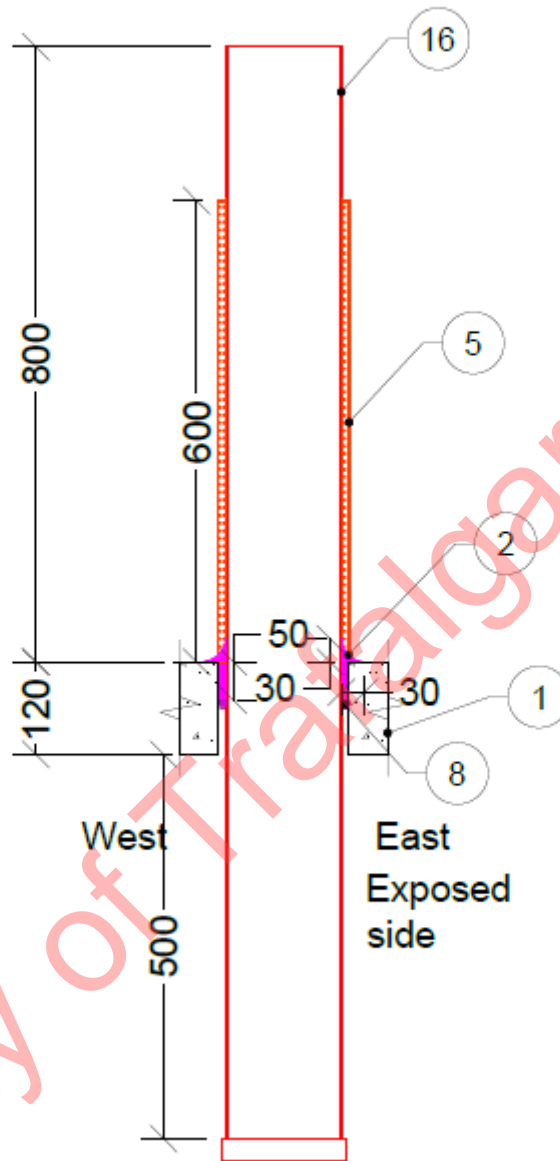
Figure 7 Cross-section D-D

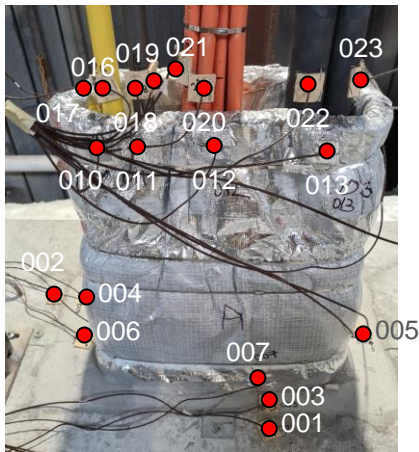
Figure 8 Penetration system A

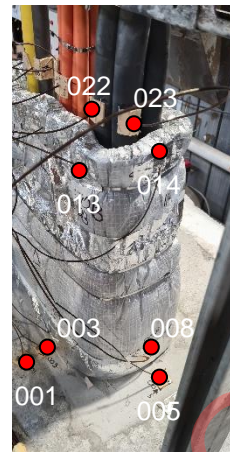
Figure 9 Penetration system A

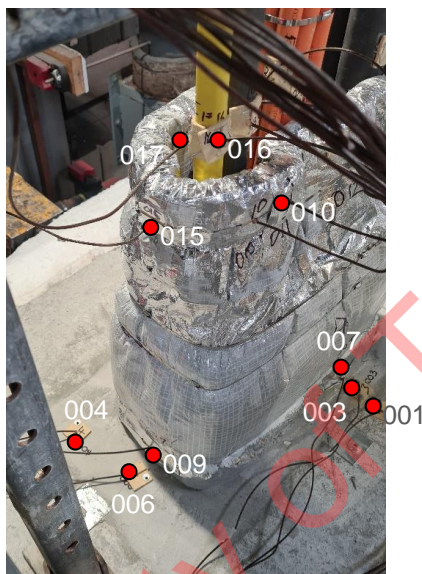
Figure 10 Penetration system A

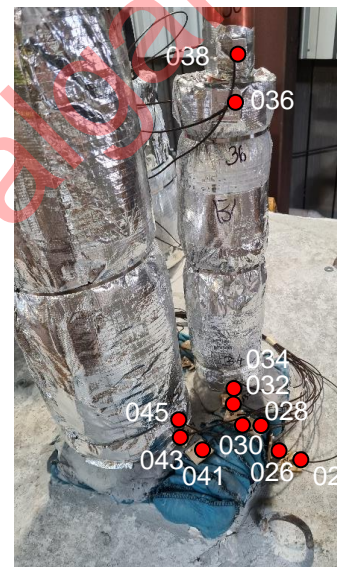
Figure 11 Penetration system B

Note: TC046-049 are not shown in these figures.

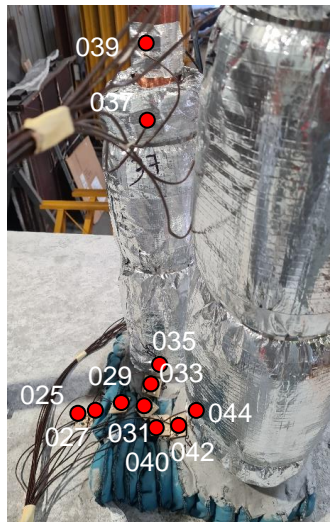
Figure 12 Penetration system B

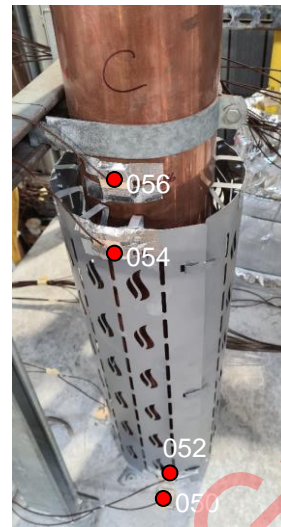
Figure 13 Penetration system C

Note: TC046-049 are not shown in these figures.

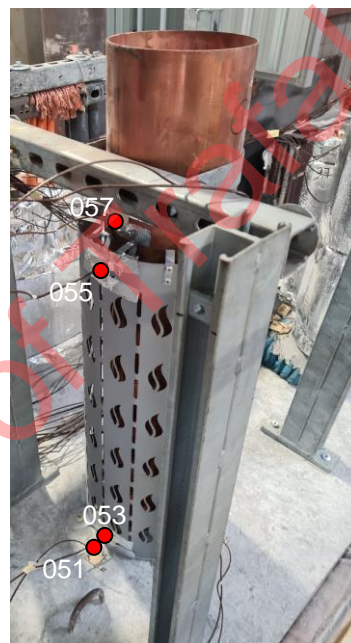
Figure 14 Penetration system C

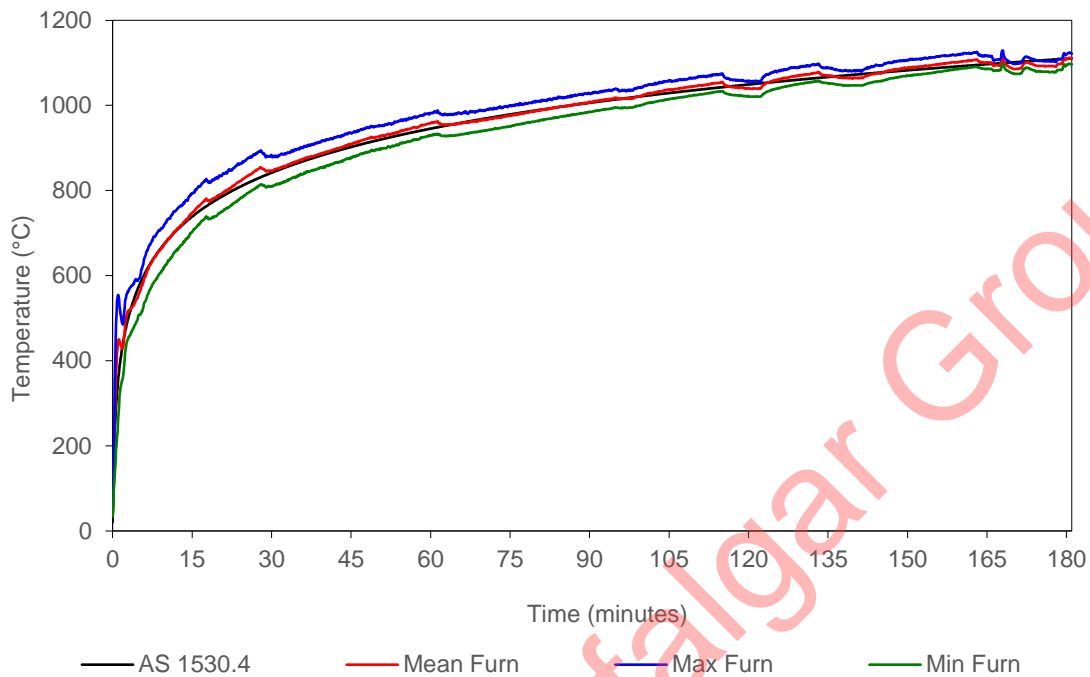
Figure 15 Furnace thermocouple temperature vs time

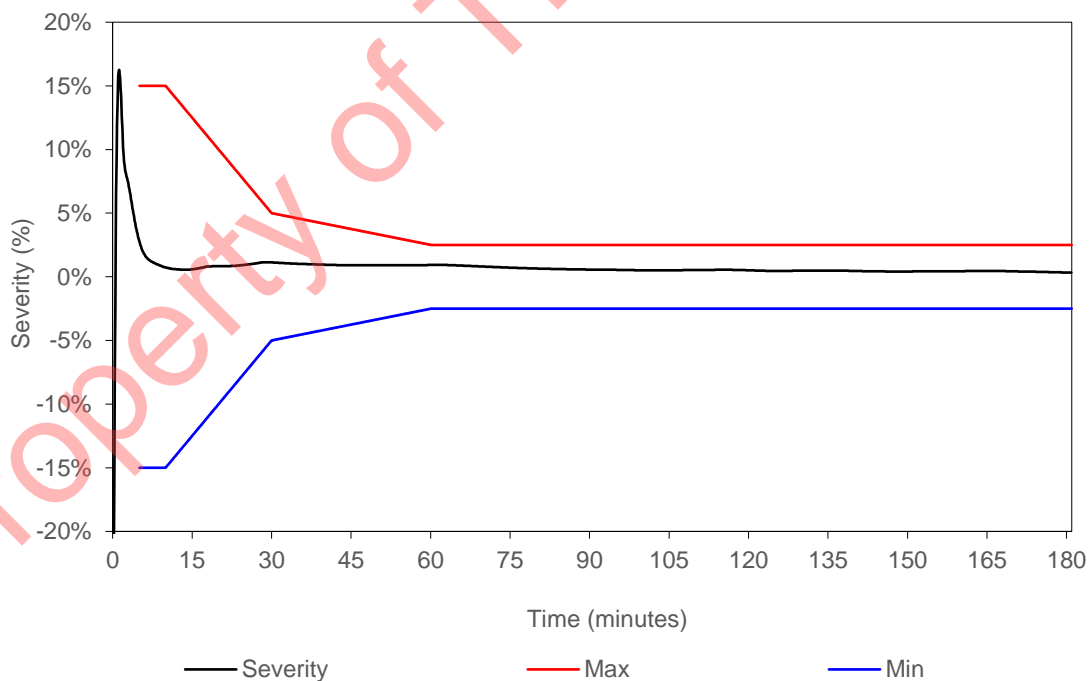
Figure 16 Percentage deviation of exposure severity vs time

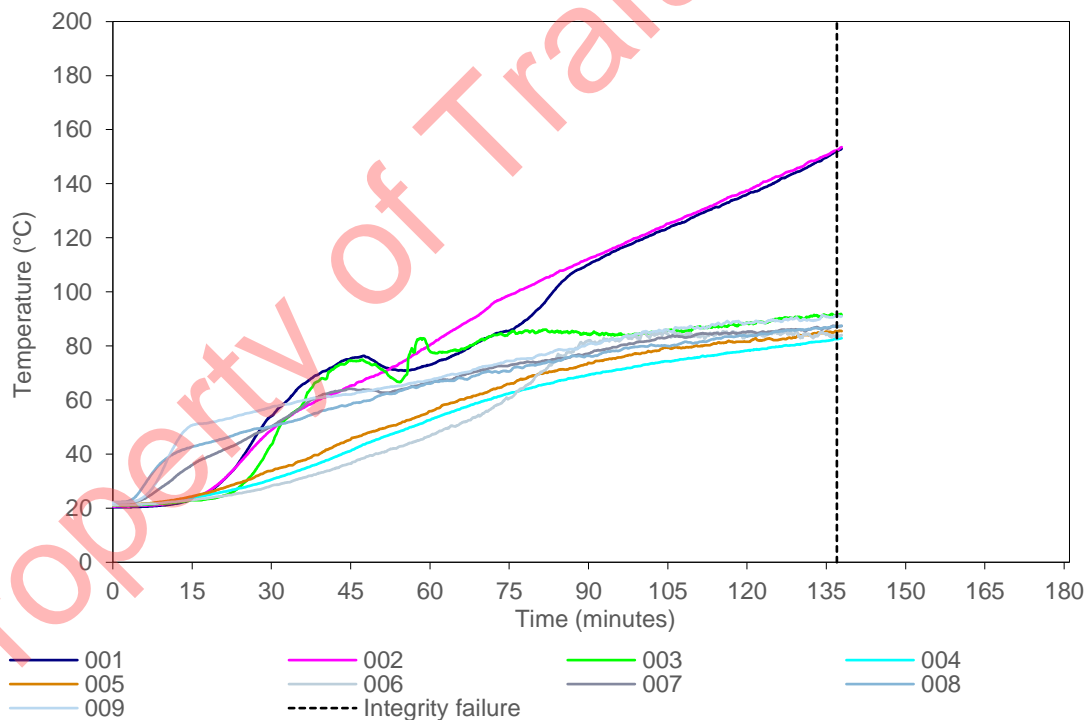
Figure 17 Penetration system A – temperature vs time

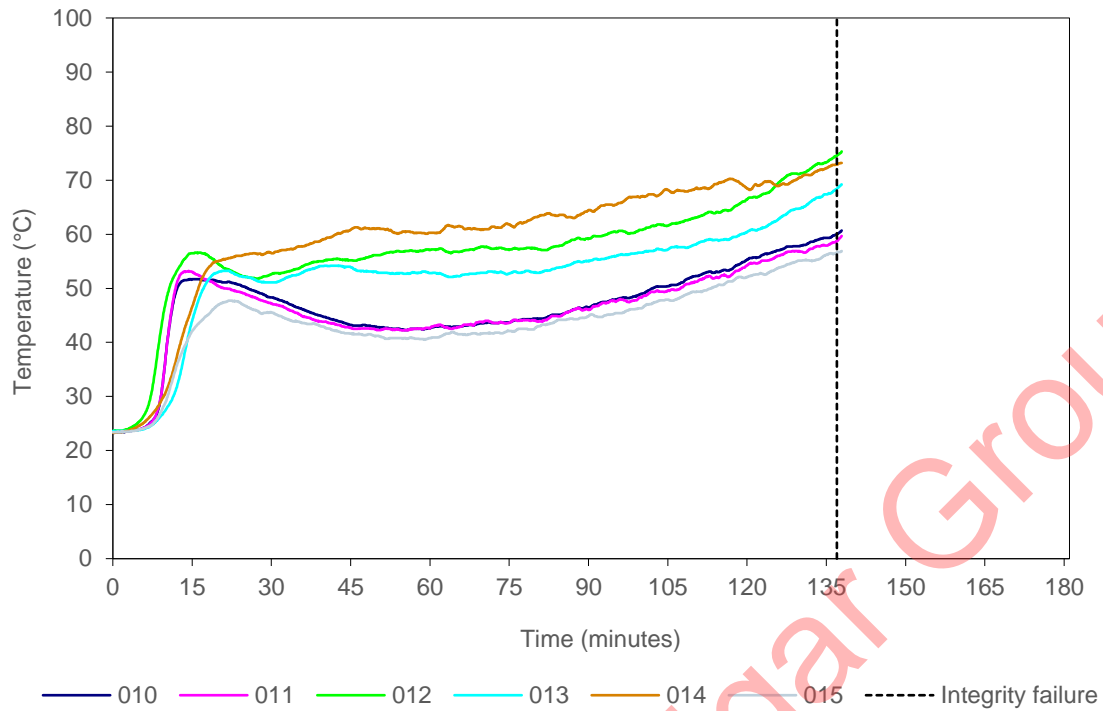
Figure 18 Penetration system A – temperature vs time

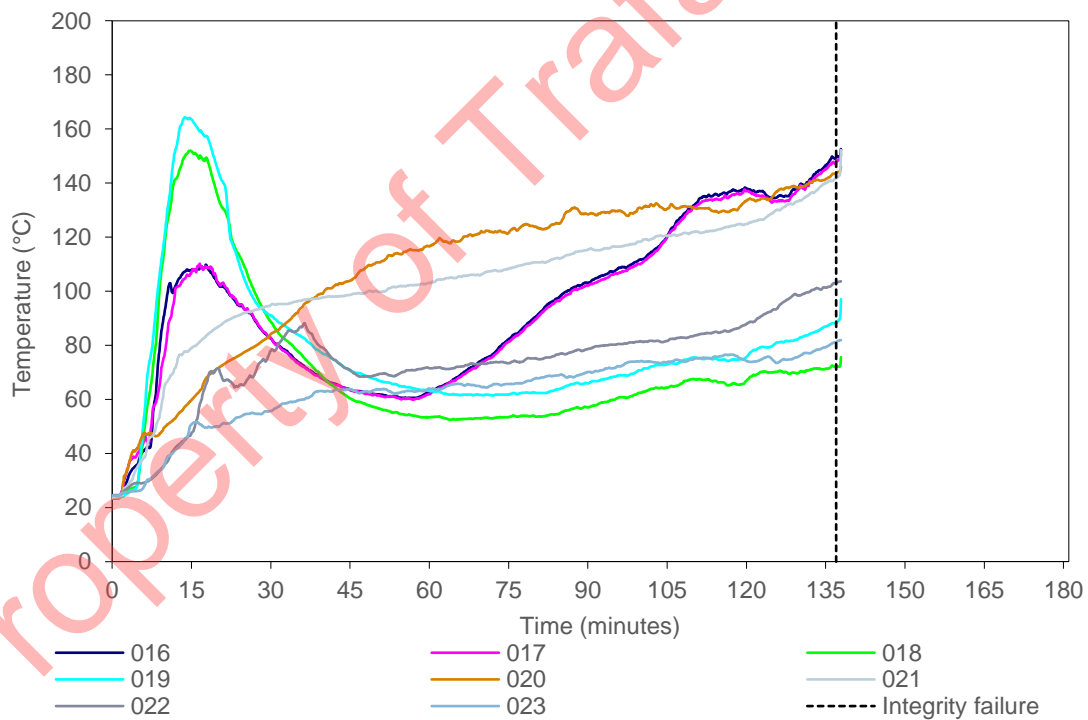
Figure 19 Penetration system A – temperature vs time

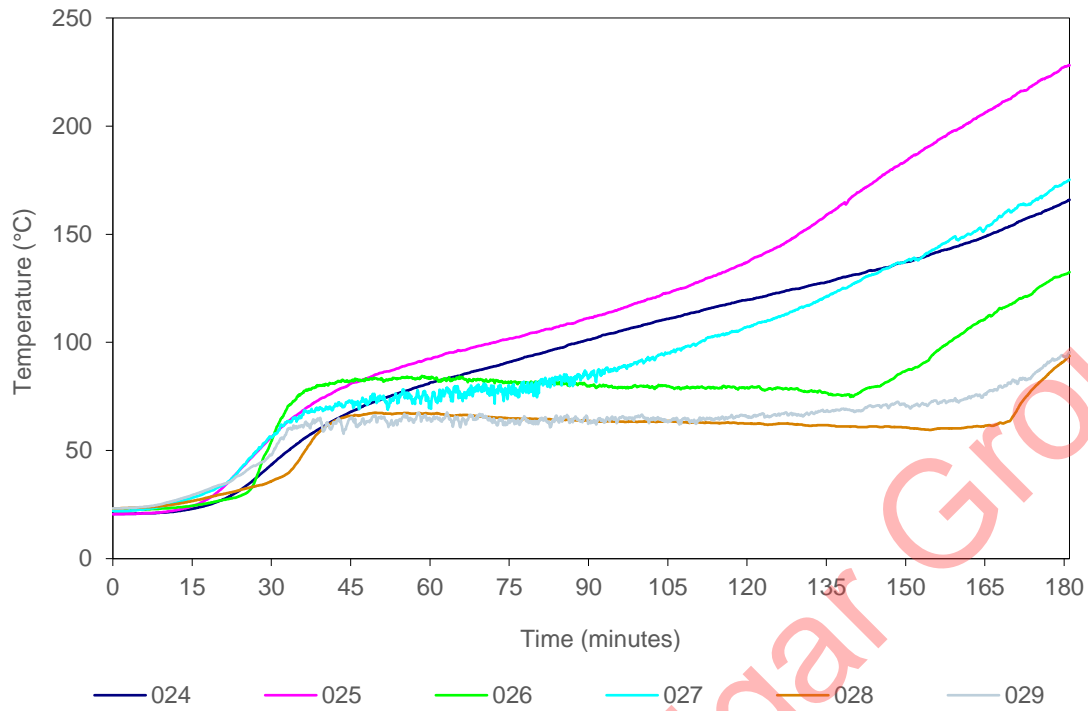
Figure 20 Penetration system B, main fire-stopping protection – temperature vs time

162	20	TC025, on separating element 25 mm from the fire pillow recorded a temperature of 203 °C. Failure of insulation in accordance with clause 2.13.3(b) of AS 1530.4:2014, where the maximum temperature of thermocouple TC025 exceeded the initial temperature by more than 180 K.
168	00	Furnace flames had started venting from service B1.
174	00	Furnace flames had started venting from service B2.
180	00	The penetration system continued to maintain integrity in accordance with AS 1530.4:2014.
181	00	Test stopped.
Penetration system C		
0	00	The fire resistance test started. The initial temperature of the test specimen was approximately 23 °C.
15	00	The penetration system continued to maintain integrity and insulation in accordance with AS 1530.4:2014.
30	00	The penetration system continued to maintain integrity and insulation in accordance with AS 1530.4:2014.
42	36	Smoke emitting from between the insulguard and the service.

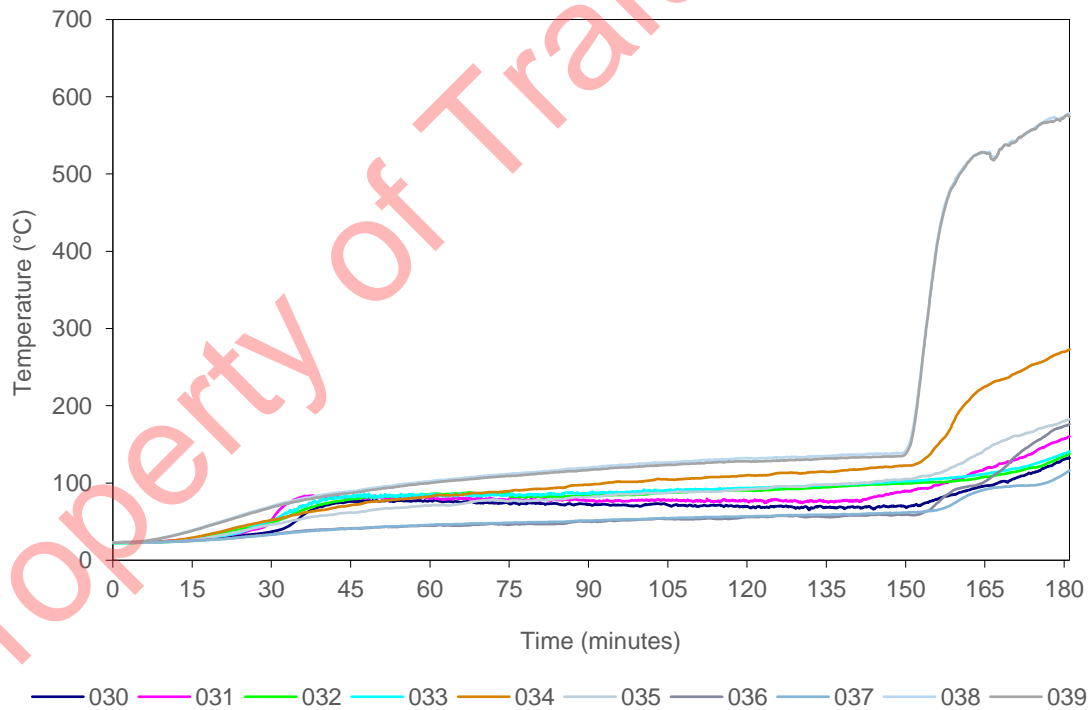
Figure 21 Penetration system B, service B1 – temperature vs time

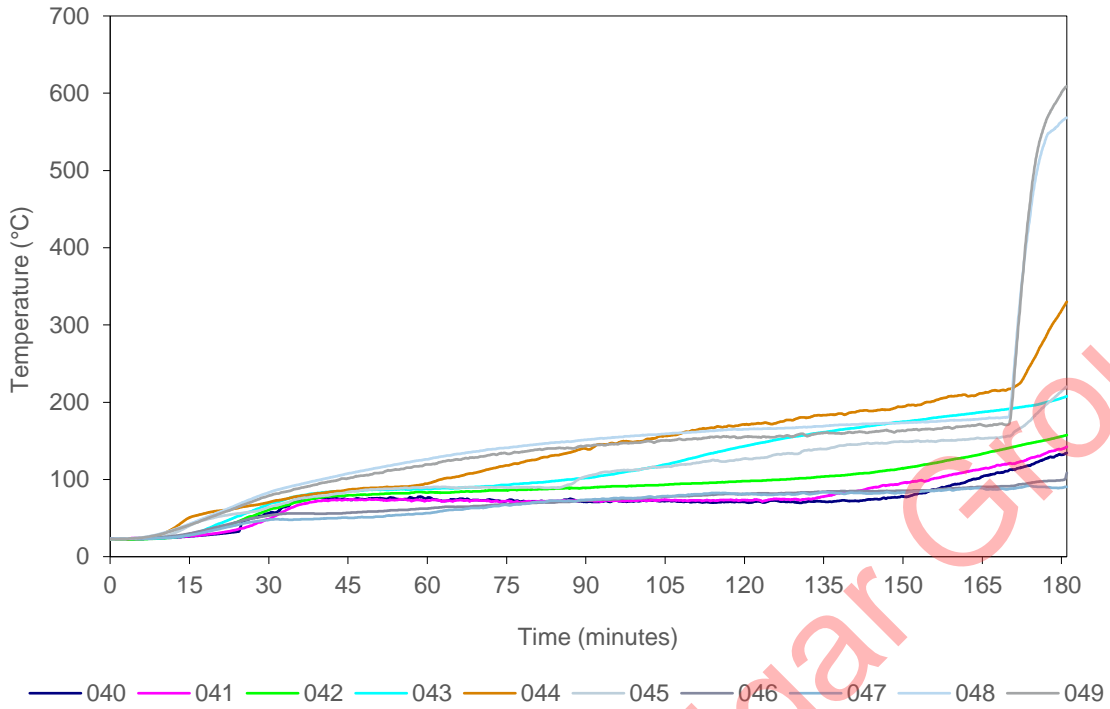
Figure 22 Penetration system B, service B2 – temperature vs time

Time		Observation
Min	Sec	
126	00	TC051, on separating element 25 mm from the insulguard recorded a temperature of 203 °C. Failure of insulation in accordance with clause 2.13.3(b) of AS 1530.4:2014, where the maximum temperature of thermocouple TC051 exceeded the initial temperature by more than 180 K.
180	00	The penetration system continued to maintain integrity in accordance with AS 1530.4:2014.
181	00	Test stopped.

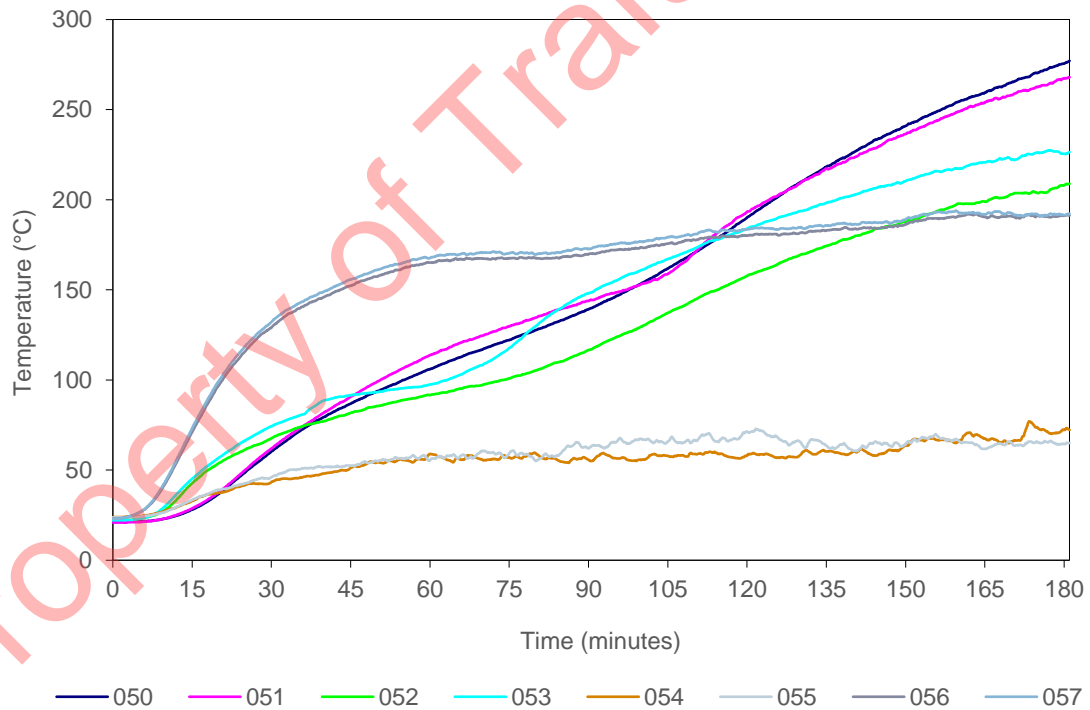
Figure 23 Penetration system C – temperature vs time

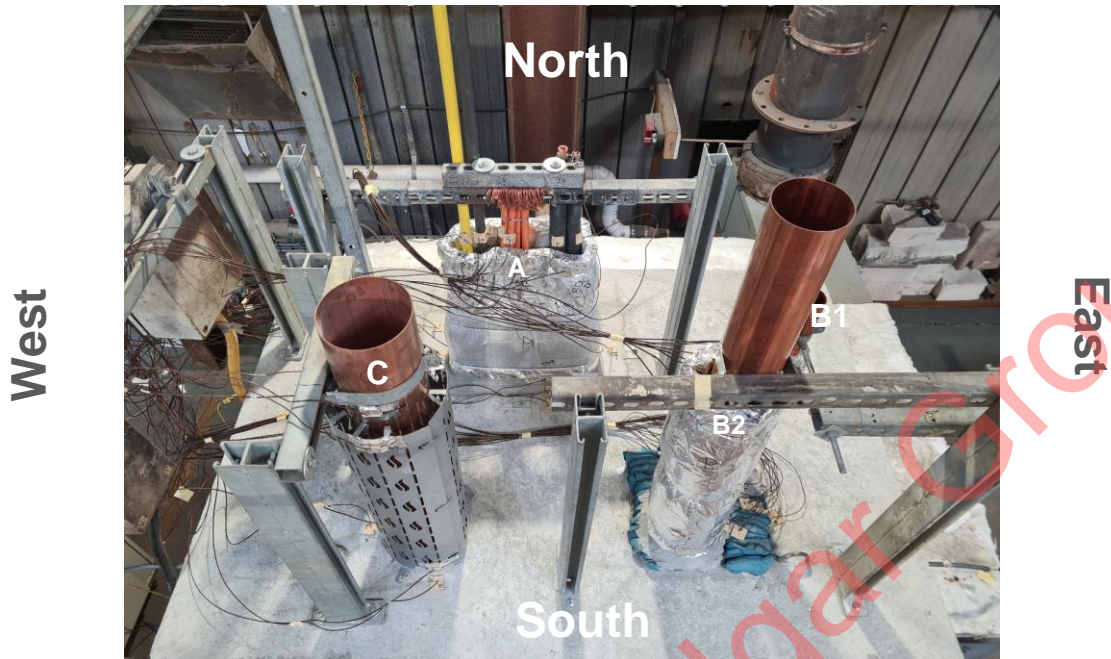
Figure 24 Unexposed face of the specimen before the start of the test

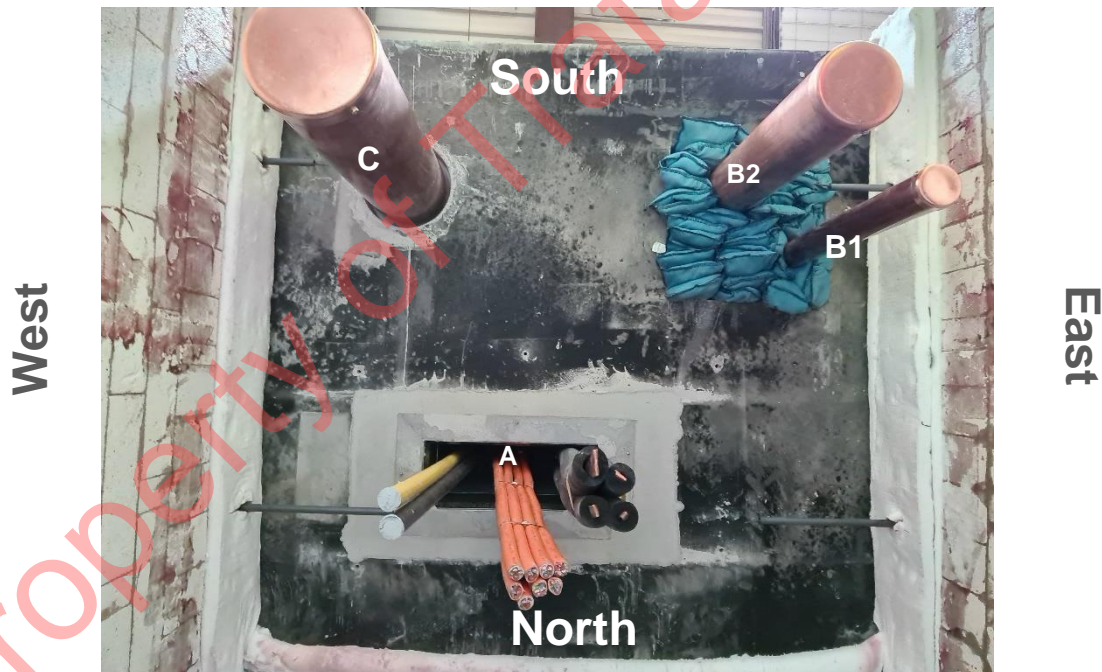
Figure 25 Exposed face of the specimen before the start of the test

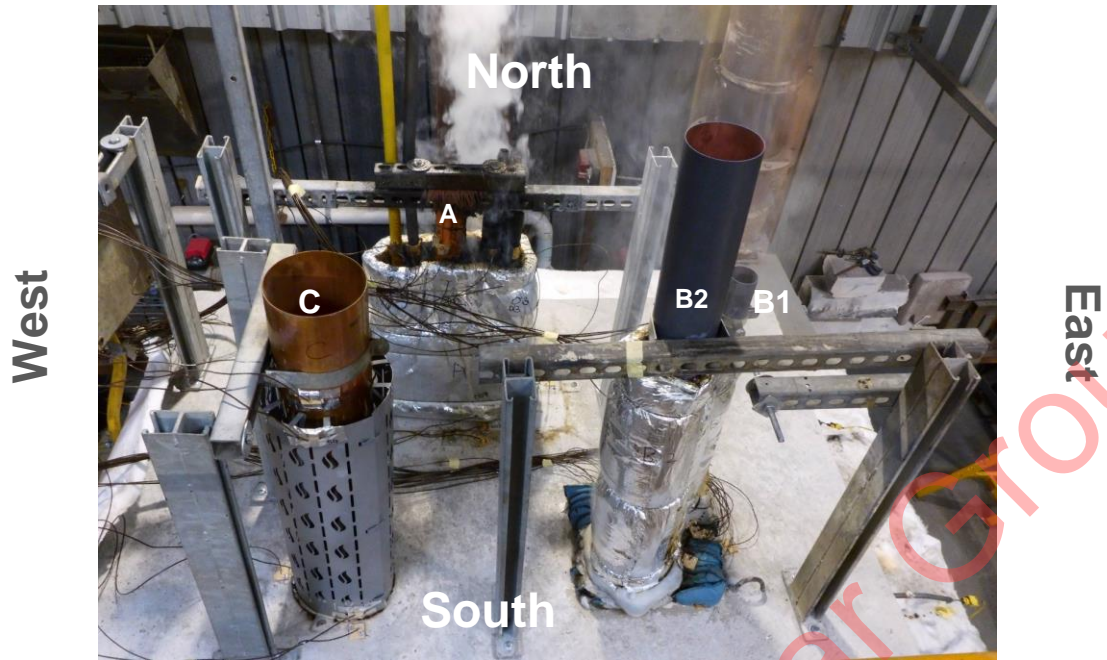
Figure 26 Unexposed face of the specimen at the end of the test

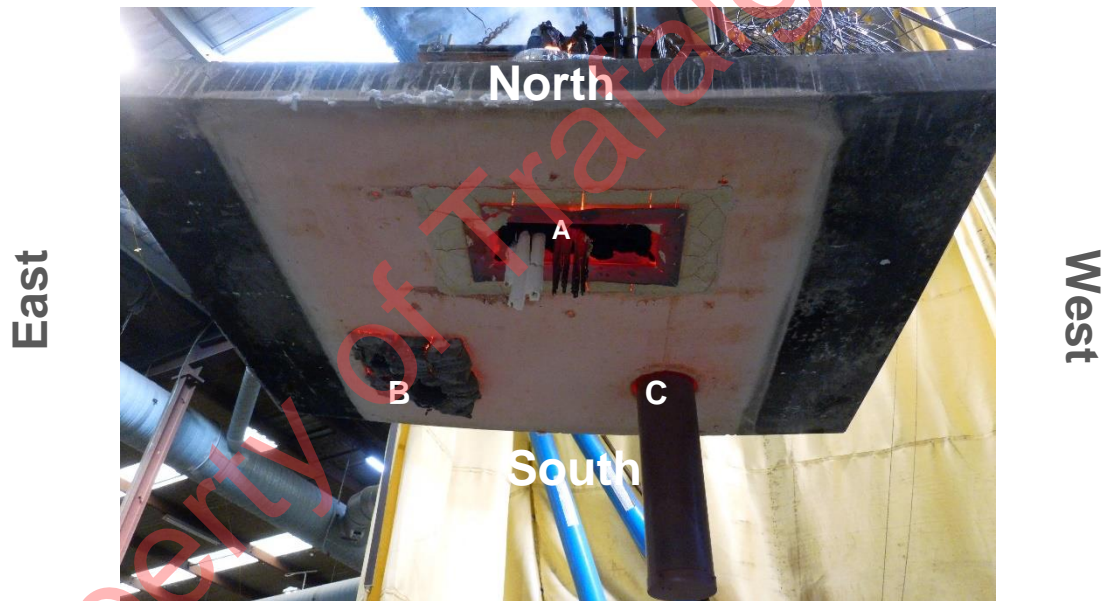
Figure 27 Exposed face of the specimen at the end of the test
